# Manhole Inspection Summary

Manhole # S53K\_\_050MH

**Location** Address: **602 s bouldin st** Cross Street: **fleet alley foster**

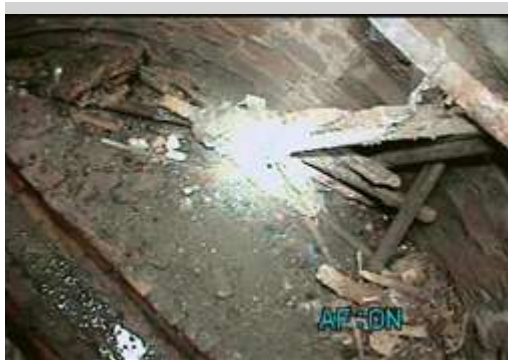
misc

bench debris

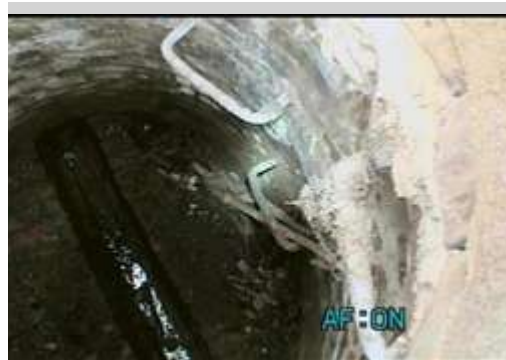
Defect 2

**Steps** Count: **3** Missing: **0** ☒ **Corroded**

steps

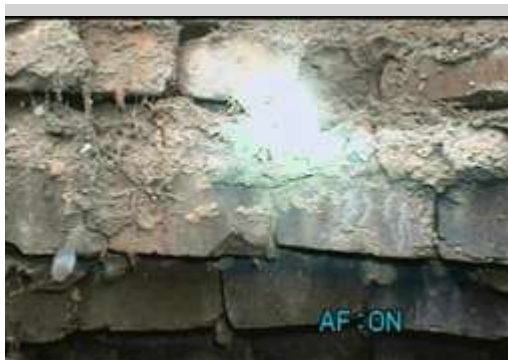
Defect 1

**Chimney / Frame Adjustment** ☒ Exists Material: **Brick and Concrete** ☐ Parged Height: **7.5** (in.)  
Condition: ☐ Sound ☒ **Cracked** ☐ Root Intrusion ☒ **Loose Brick** ☒ **Deteriorated**  
Infiltration: ☒ None ☐ Joint ☐ Cracks ☐ Mortar ☐ Roots ☐ Wall

cracked, deteriorated, loose bricks, frame adjustment

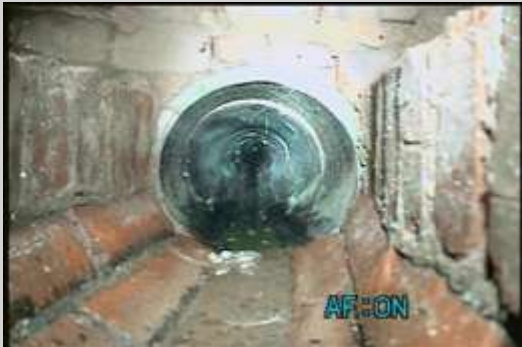
12 O'Clock Outflow

8 in. Circular Gravity Sewer  
Pipe Out @ 12 O'Clock

Pipe Material: **Clay** ☐ Pipe Lined

Invert Depth: **6.81** (ft.) Flow Characteristics: **None**

Infiltration: **None** Pipe Seal Cond: **Unknown**

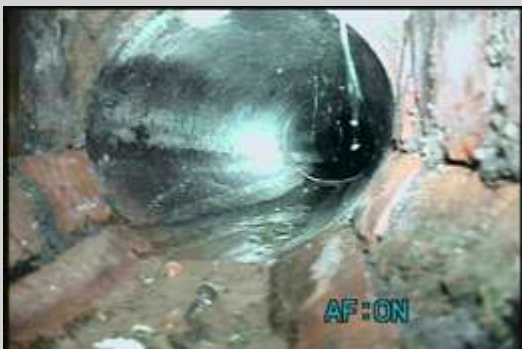
6 O'Clock Inflow

8 in. Circular Gravity Sewer  
Pipe In @ 6 O'Clock

Pipe Material: **Clay** ☐ Pipe Lined

Invert Depth: **6.75** (ft.) Flow Characteristics: **None**

Infiltration: **None** Pipe Seal Cond: **Unknown**
